DIVISION OF OIL, GAS AND MINING

801-538-5340 801-359-3940 (Fax) INSPECTION REPORT

Mine Name: _	Savage Coal Terminal	County: Carbon	Permit	: Number: _	Calledia
Permittee and	l/or Operator's Name: S	avage Industries, Inc.			
Business Add	lress: 5250 South 300 Wes	t, Suite 200, SLC, UT	3 84107 / PO Box 5	87, Wellin	gton, Utah 84542
	ng Activity: Underground				Other
Company Off	ficial(s): Dan Guy, Boyd	Rhodes			
	(s): Gregg Galecki, Joe H		Official(s): None		
Weather Con-	. ,				
Existing Acre	eage: Permitted 160	Disturbed 122	Regraded	Seede	d
Status: Activ	ve XXX

PERMIT NUMBER: C/007/022

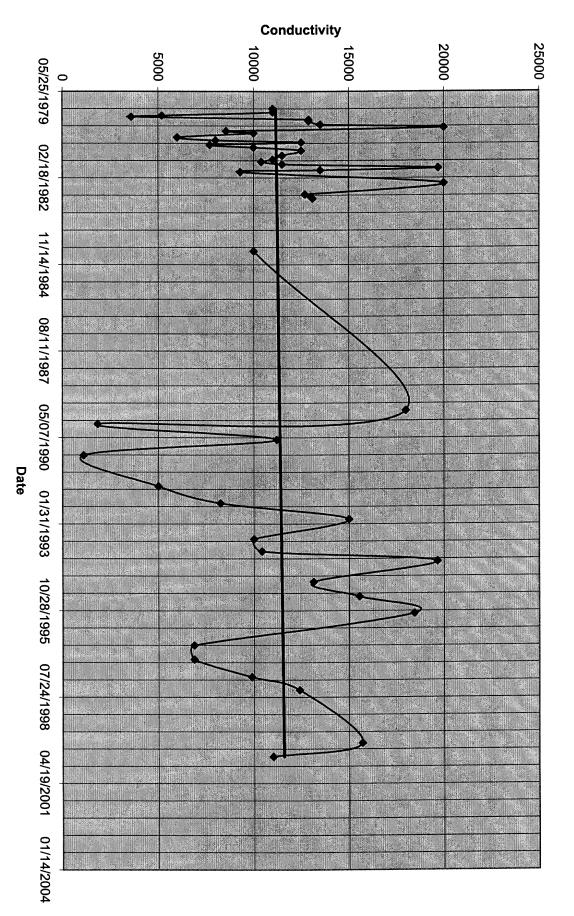
Savage Coal Terminal

Another source of concern was the elevated Sulfate, Conductivity, and Total Dissolved Solids (TDS) observed in the January 2000 sample. Mr. Dan Guy theorized the lower values exhibited in the summer sample is attributed to dilution of the groundwater from infiltration of canal water located up-gradient of the property. A review of the data collected since 1979 loosely supports the theory. A linear regression of the Field Conductivity and TDS versus time indicated the conductivity has remained constant while the TDS has increased from approximately 8,000 to 13,000 mg/l. (See attachments)
